Danube Bridge Sinzing (Germany)

Project description

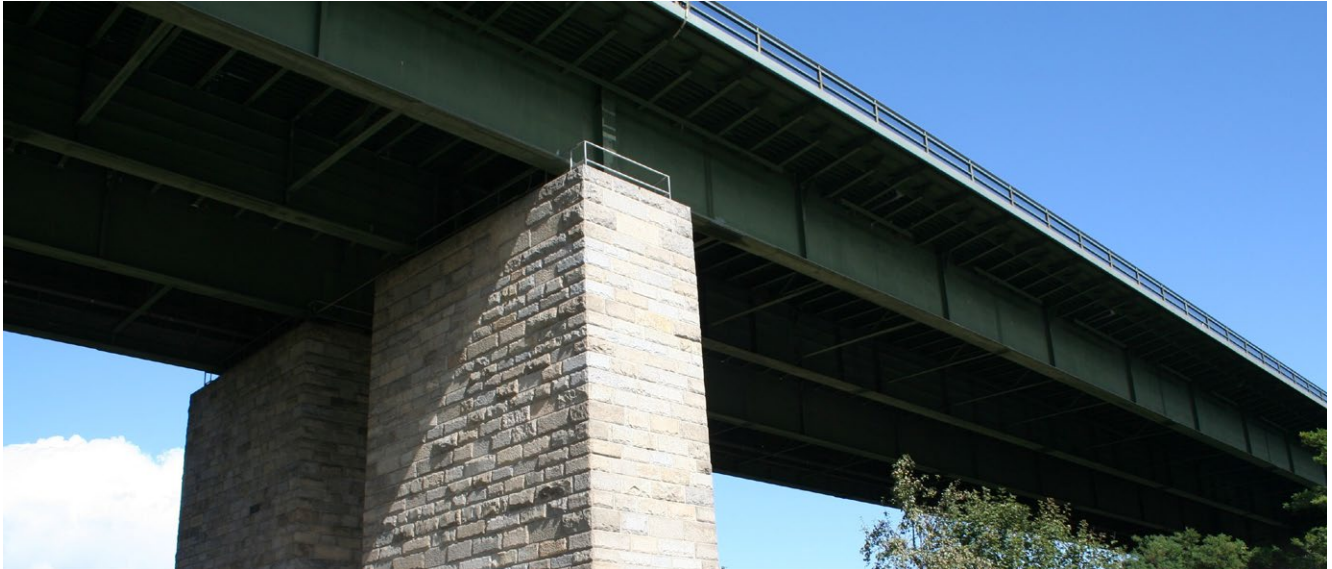
Rapid wear of PTFE sliding discs of the bridge deck's support bearings required explanation

The deck support bearings of the Danube Bridge in Sinzing were observed to suffer unusually fast abrasion of their PTFE sliding discs, requiring disc replacement after just five years of service.

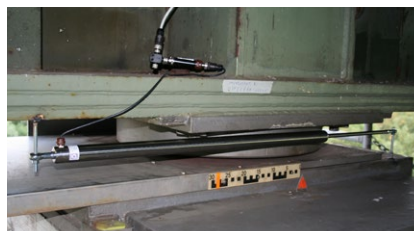
A longitudinal movement measuring sensor as installed at one of the deck's support bearings

It was decided to make use of modern structural health monitoring (SHM) technology to evaluate the exact movements of the bridge deck during a two-week period. The short-term nature of the project made a ROBO®CONTROL "Portable" SHM system ideal for this purpose.

A clear correlation between movement and temperature was established, with extrapolation of the recorded data indicating accumulated sliding distances of approximately 2.5 km per year. It could be concluded that these movements were the primary cause of the wear problem, and that the use of ROBO®SLIDE instead of PTFE would significantly prolong the life of the bearings – confirming the proposed solution.

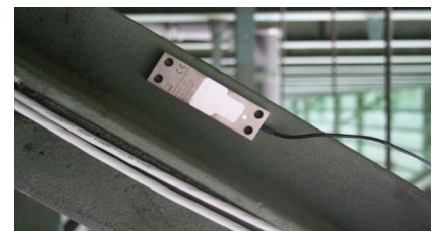
Strain measurement on one of the bridge deck's steel members
