Obermatt Bridge (Switzerland)

Project description

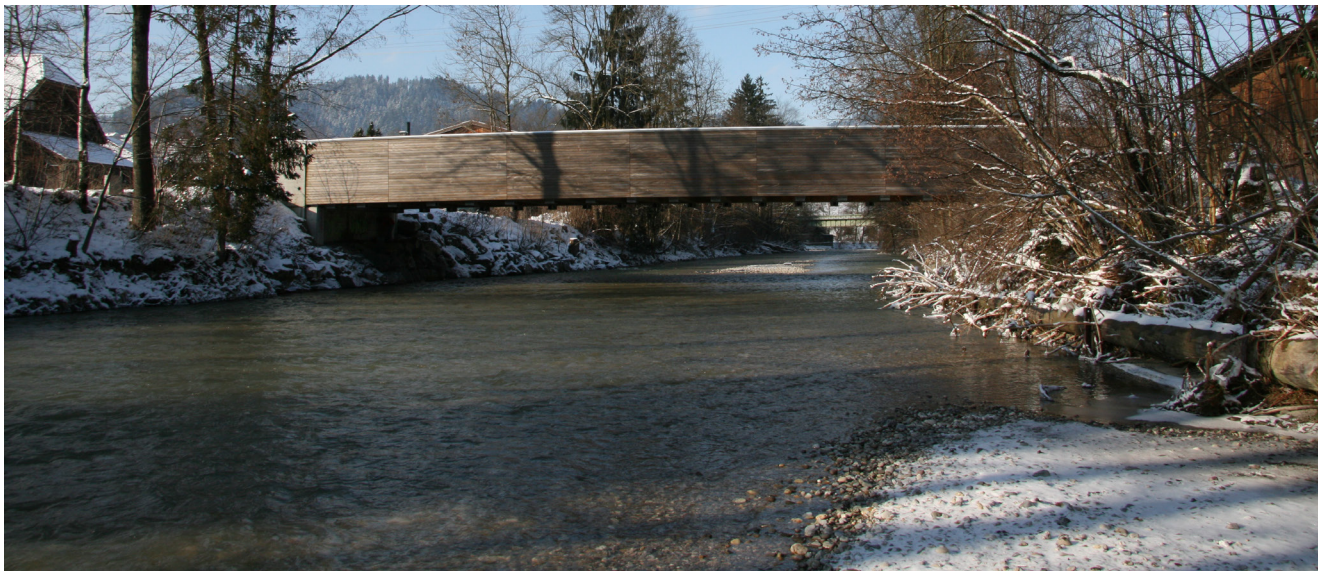
The bridge crosses a river near Berne, Switzerland's capital city.

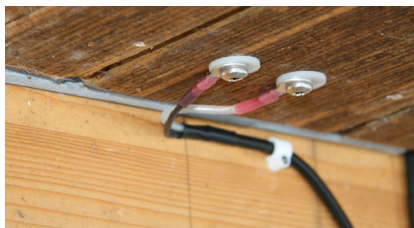
Installation of the ROBO®CONTROL automated monitoring system.
