Leaning Tower of St. Moritz (Switzerland)

Project description

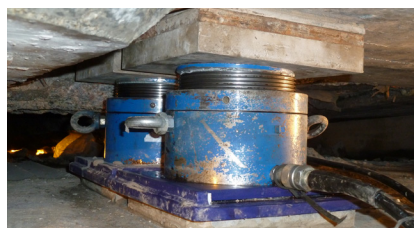
Special sliding equipment ensures the safety of the tower during the lowering works

Four hydraulic jacks with a total capacity of 8000 kN were used, placed on guided sliding equipment in order to resist horizontal forces. Additional vertically installed jacks enabled the tower's position to be adjusted during the lowering works.

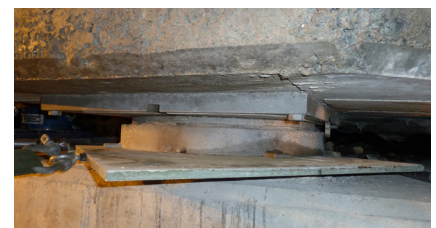
Modification of an existing pot bearing

In order to reduce the tower's tilt, it was decided to lower it at the hill side by 40 mm, by modifying the bearing at that location. This would have the effect of reducing the deviation from vertical at the top of the tower by 160 mm.
