ROBO®CONTROL – Monitoring Solutions Portable and Permanent Systems

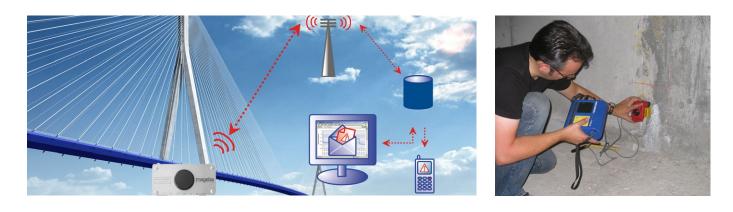
ROBO®CONTROL Systems

Permanent Systems for long-term monitoring and investigative applications, featuring permanent power supply and transmission of data to a central server

Portable Systems investigative applications

- Limited to static monitoring applications at low frequencies
- The number of sensors that can be integrated is limited

- Dynamic and static monitoring missi-• ons possible at all frequencies
- Unlimited number of sensors can be • integrated

- Dynamic and static monitoring tasks possible at all frequencies
- Measuring time limited due to battery capacity

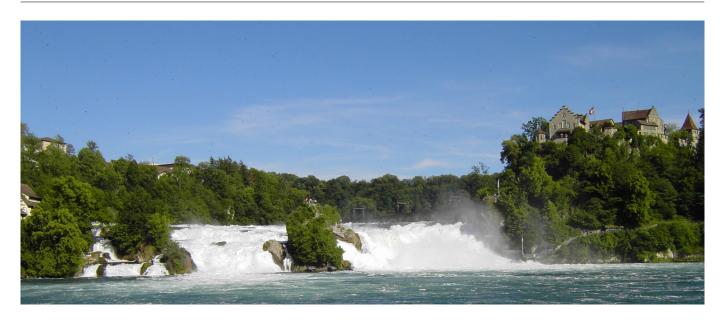
Rhine Waterfalls (Switzerland)

Rock anchors installed to stabilize the rock wall below the castle showed unexpected force changes, leading to concerns that some sliding surfaces had developed. To ensure the ongoing safety of the terrace, additional rock anchors with measuring devices were installed, with a ROBO®CONTROL system monitoring anchor force changes.

The rock wall of particular interest is about 66 ft (20 m) high and was stabilized with 11 additional rock anchors. The installation conditions were challenging due to high exposure, noise and dampness.

A ROBO®CONTROL permanent "BASIC" system was connected to the installed rock anchors, its flexibility allowing compatibility with the load cells of the anchors.

It could be concluded that the rock wall has been well stabilized by the additional rock anchors. The forces are now very stable and rock movements are negligible.

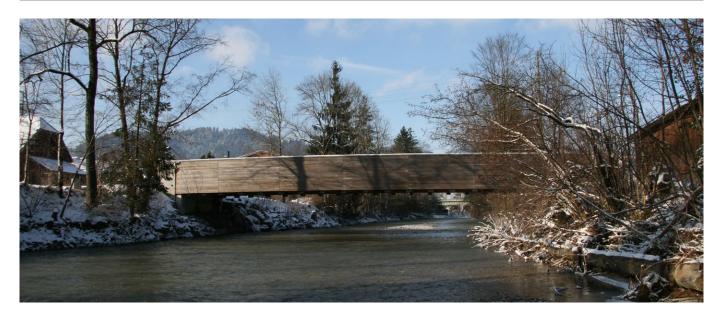
Obermatt Bridge (Switzerland)

The bridge crosses the Ilfis River between the villages of Obermatt and Emmenmatt in the Swiss Alps. It has two lanes and average daily traffic of approx. 2,400 vehicles, and when it was rebuilt in 2008, it had a new safety feature: in the case of severe flooding, it can be raised by up to 27.5 in (70 cm) to prevent damage from floating debris in the swollen river.

In cooperation with the University of Bern, the dampness of the crucial elements of the bridge shall be measured over a minimum period of three years. The key features of the system include:

- Reliable long term measurement of timber moisture content at crucial locations, especially in the area between the superstructure of the bridge and its pavement.
- Immediate alarm notification by email and SMS if threshold values of the timber humidity are exceeded (> 25%)

The measurements to date show that the timber moisture content of the bridge lies within an acceptable range. The long-term monitoring system will enable the client to understand the structural performance of the bridge and to recognize any changes as they occur. The system's alarm settings ensure automatic notification should timber moisture content ever rise unexpectedly. And it is hoped to prove the durability of well designed, maintained and operated timber bridges.

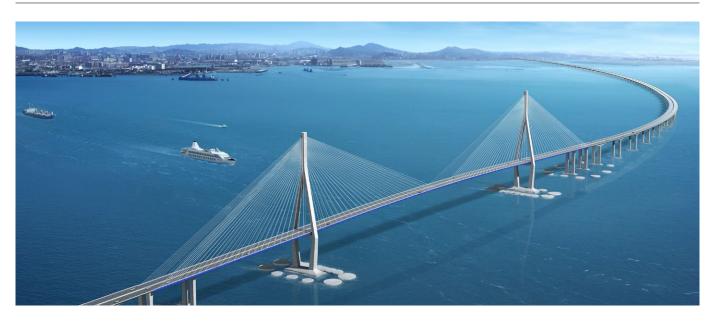
Incheon Grand Bridge (South Korea)

The design of this exceptional bridge required deck expansion joints with extraordinary movement capacity 75.6 inch (1,920 mm). The bridge engineers required verification of:

At 7.6 mi (12.3 km) long and with a main cable stayed span of 2,625 ft (800 m), the new Incheon Bridge is one of the five longest of its type in the world.

In order to measure the movement of the cable stayed bridge section and the performance of the 24-gap modular expansion joints, a ROBO®CONTROL remote monitoring system measures the longitudinal and transverse movements of the deck at the joint.

The system measures the longitudinal movements of the first, second and last lamella beams of the joint, and the entire gap width. It also measures deck rotations and air and structural temperatures.

- The predicted design movement and rotation behavior of the bridge deck was confirmed
- The exceptional expansion joint is performing very well, with no impacts and with satisfactory opening and closing of all gaps.

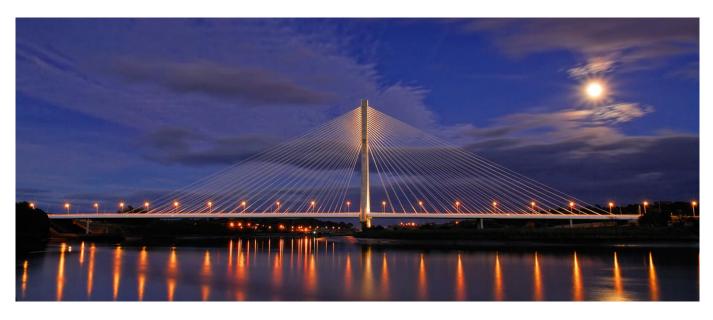
River Suir Bridge (Ireland)

The design of the cable stayed bridge was determined to be critically dependent on the dynamic behavior of its cables. The costly installation of stay cable dampers shall be assessed in two steps:

The River Suir Bridge is part of the N25 bypass of the city of Waterford. The cable stayed structure has an overall length of 1,526 ft (465 m), with individual spans of 131 ft, 230 ft, 295 ft, 755 ft, and 115 ft (40 m, 70 m, 90 m, 230 m and 35 m, and a width of 100.4 ft (30.6 m). Its concrete pylon has a height of 314 ft (95.6 m) above the deck, and the bridge was completed in Sep-

Before opening to traffic, mageba performed measurements on all 76 stay cables using a ROBO®CONTROL "Portable" system, providing data on actual cable forces and cable damping. Afterwards, a ROBO®CONTROL "Permanent" monitoring system was installed by mageba. The system includes 62 measurement channels in total. The data is automatically analyzed on site and presented via the mageba web interface, with an overview of the current situation and graphical representation of the overall performance to date.

Thanks to the data provided by the monitoring system, it could already be concluded that it will not be necessary to install dampers on all cables, resulting in great financial savings for the client. However some selected cables may be fitted with well-specified dampers at a later date.

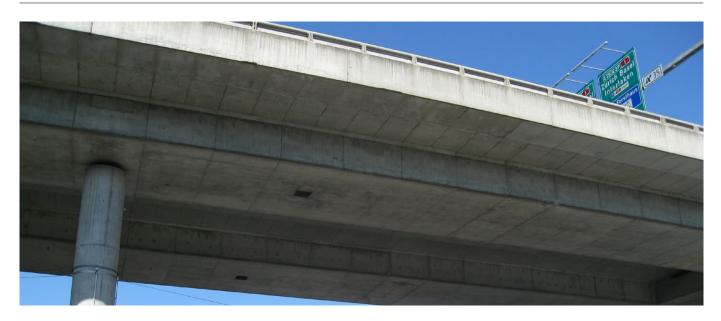
Weyermannshaus Viaduct (Switzerland)

During a detailed visual inspection of the underside of the bridge, considerable cracking was discovered at several coupling joints of the post-tensioned structure. Uncertainty about the time of crack appearance raised concern about structural safety. In order to ensure serviceability for another 35 years of operation, mageba was contracted to install a remote, long term monitoring system. The project was conducted in cooperation with the responsible renovation engineer that was already planning other remedial works such as replacement of bearings, joints and drainage systems. The monitoring data would serve in determining appropriate remedial works for the structure.

A ROBO®CONTROL permanent "ADVANCED" system was needed to fulfil the project requirements. In order to support the calculations of the engineer, changes in crack widths due to known traffic loads and temperature variations had to be monitored. It was decided to proceed in three steps:

- Calibration measurements: Single load scenarios with a 40t truck were simulated at different speed levels.
- Traffic load impact: Measurements at high frequency (200Hz) were conducted to assess the impact of actual traffic loading during a period of one week in each season of a year.
- Long term monitoring: Installation of a permanent monitoring system to assess long-term impacts, with all data presented via a web interface.

- Structural safety and serviceability were confirmed to be satisfactory under current loading conditions.
- A fatigue assessment confirmed another 35 years of operation for the main structure.
- 3. No major rehabilitation works are required.

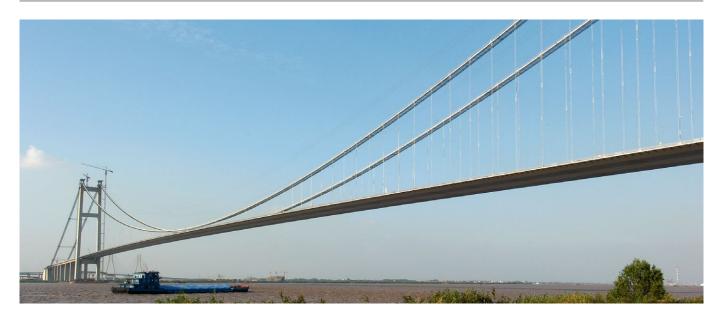
Run Yang Crossing (China)

After completion of construction and opening to traffic, unexpectedly large movements of the structure were observed, which resulted in excessive wear on bearings and expansion joints. Especially the sliding materials and the elastomeric control springs of the bridge's expansion joints showed clear signs of accelerated wear.

The monitoring system was used to conclude that the movements at the suspension bridge greatly exceeded expected values. The bridge engineer could use the information provided to plan remedial works to improve the structural performance and to prevent excessive wear of the bearings and expansion joints, for instance by the addition of damping devices, which can be easily installed on a finished structure during operation.
