# Expert Knowledge

## Corrosion protection for bridge expansion joints and structural bearings

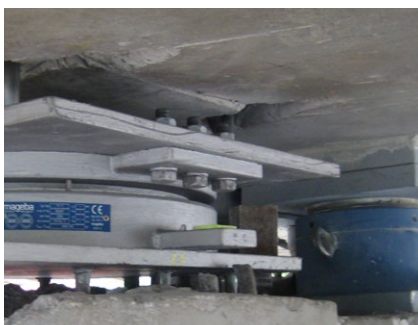
When a bridge bearing requires to be replaced, the costs (including for lifting of the bridge deck) can be substantial

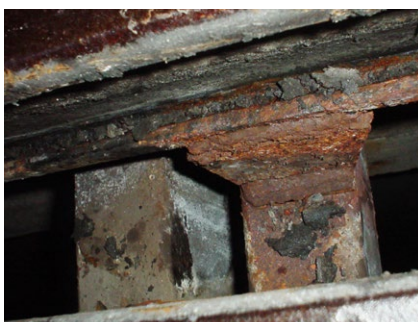
Corrosion of expansion joints, and at their moving/sliding interfaces in particular, can cause severe deterioration, often necessitating complete replacement of the joint which causes severe cost impact on traffic
