Kiskörei Tisza Bridge (Hungary)

Project description

mageba scope

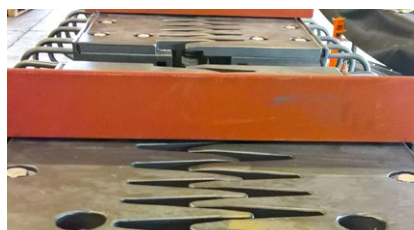
TENSA®FINGER joint were built in sections leaving space for the new railway tracks

The joints were installed in sections due to the railway tracks that were also replaced during the renovation works.
