# Expert Knowledge

## Corrosion protection for bridge expansion joints and structural bearings

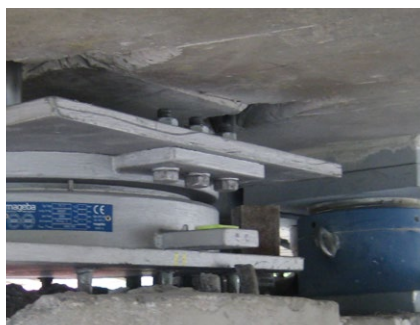
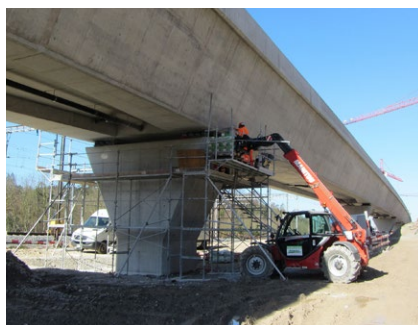
When a bridge bearing requires to be replaced, the costs (including for lifting of the bridge deck) can be substantial

Repair works on bearings and expansion joints can be very expensive and have a significant impact on traffic, and the impacts are likely to be much greater when a component needs to be fully replaced, as it may arise when corrosion damage has become very serious.

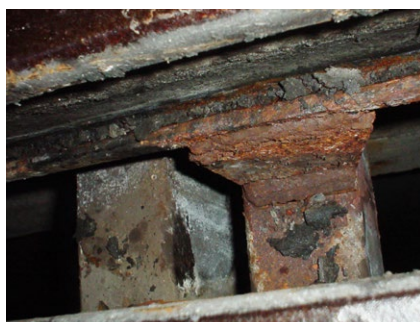
Corrosion of expansion joints, and at their moving/sliding interfaces in particular, can cause severe deterioration, often necessitating complete replacement of the joint which causes severe cost impact on traffic
