Expansion joints

mageba repair and replacement services for modular expansion joints

“Box in box” method

Repair and replacement of old or damaged modular expansion joints

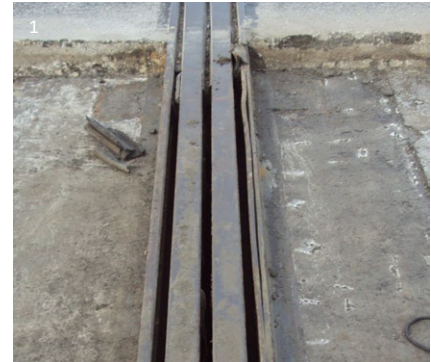
- 1 Old 3-gap expansion joint after removal of asphalt and waterproofing membrane at each side
- 2 Cutting to enable the support bars of the old joint to be lifted out
- 3 Substructure after cleaning
- 4 Lifting in of the new structure, consisting of a lamella beam and connected support bars, complete with boxes

In order that the existing substructure can be treated with new corrosion protection, the asphalt and road waterproofing membrane are removed to a distance of 1 m from the joint. This also enables any rutting of the asphalt to be addressed.

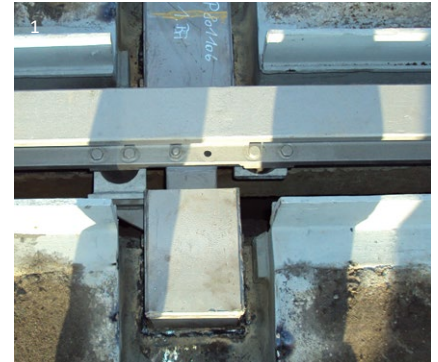
- 1 View of a support bar box of the new joint, placed inside the larger support bar box of the old joint and welded all around
- 2 View of one new support bar and its boxes, following placing of mortar to fill out the voids between new and old boxes
- 3 New expansion joint during installation, after connection to the structure
- 4 Application of waterproofing to bridge deck at each side of the new joint

The new joint, consisting of lamella beams and pre-connected support bars and support bar boxes, is lifted into place and precisely positioned, with the new support bar boxes inside the open boxes of the old joint. Because existing expansion joints sometimes develop rotations, a height difference between the bridge deck and the abutment may become apparent at this stage, which may require the support level within some existing support bar boxes to be adapted. The new support bar boxes are then welded all around into the existing boxes. After this, the welds are cleaned by blasting and given a primer coat.

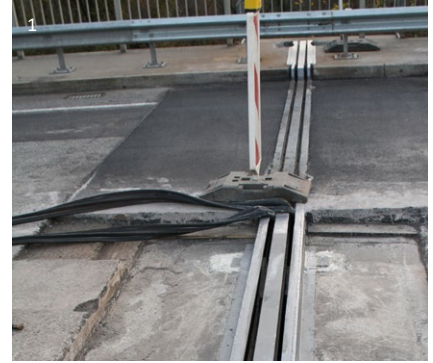
- 1 Renewal of a 2-gap modular joint (installed in phases) almost completed
- 2 Traffic management during renewal of a joint in phases (one lane at a time)

If the expansion joint is to be replaced in two or more phases (e.g. one traffic lane at a time to reduce impact on traffic), then the lamella beams of each phase must be welded together on site using the Secheron process. mageba's installation team has the required certification.
