D1 – Hričovské Podhradie – Lietavská Lúčka (SK)

Project description

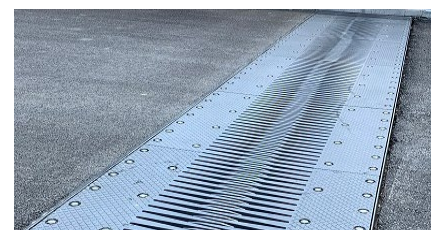
One of the installed TENSA®FINGER expansion joints

For this project mageba delivered TENSA®FINGER expansion joints of type F560X (maximum movement capacity: ± 280 mm) and F320X (maximum movement capacity: ± 160 mm) single gap joints with lengths of 30 m and 28.5 m respectively.
